## Property Condition Assessment

LOCATED AT:  
640 Hawthorn Ln  
Davis, CA 95616

PREPARED EXCLUSIVELY FOR:  
The Episcopal Church of St. Martin

INSPECTED ON:  
Wednesday, September 17, 2025

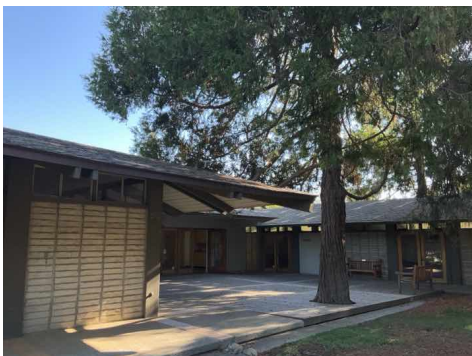
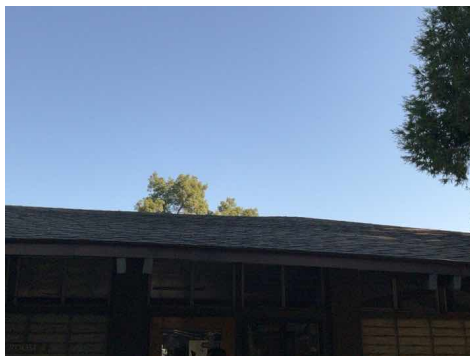
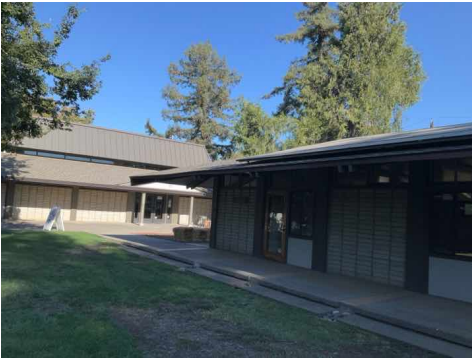
7: The dips in the roof eaves and the field of the roof are absolutely normal and not of any structural concern. This is normal movement, especially with large roof eaves in this type of construction.

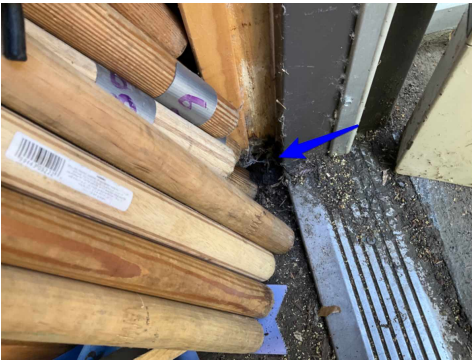
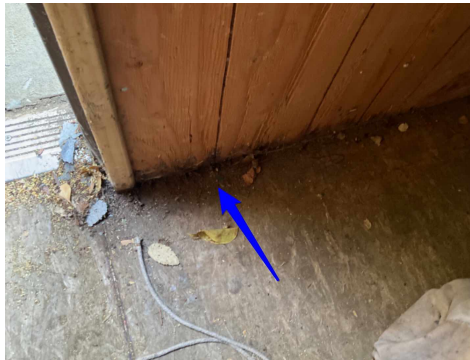
**s-8:** There is moisture damage, mainly to the floor around the door of the storage shed used by the Boy Scouts. Further evaluation and repairs are recommended.

**8:** There is moisture damage, mainly to the floor around the door of the storage shed used by the Boy Scouts. Further evaluation and repairs are recommended.

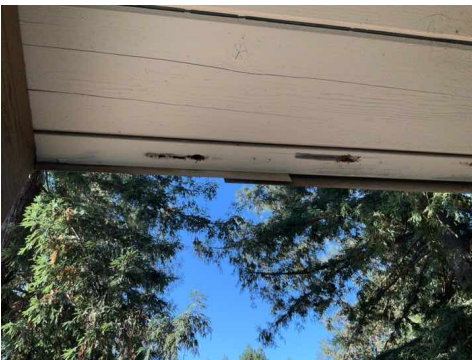
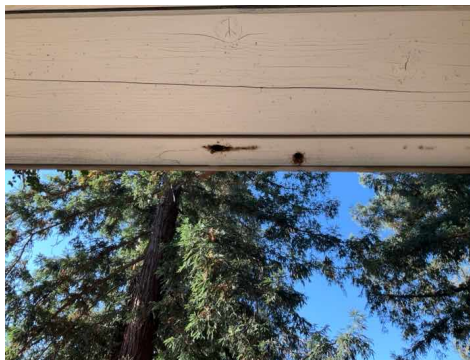
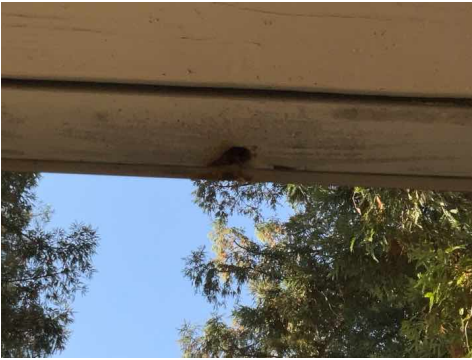
**s-9:** There is damage to the eaves, consistent with pest and or dry rot. Recommend further investigation by a licensed pest inspector.

**9:** There is damage to the eaves, consistent with pest and or dry rot. Recommend further investigation by a licensed pest inspector.

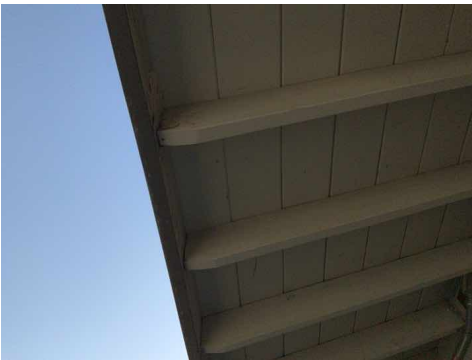
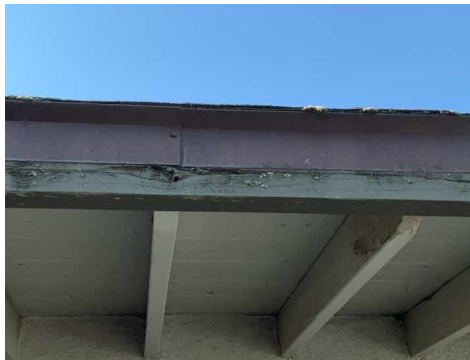
**s-10:** There's dry rot in the roof eaves and trim. Recommend further investigation and repairs be made by qualified contractor.

10: There's dry rot in the roof eaves and trim. Recommend further investigation and repairs be made by qualified contractor.

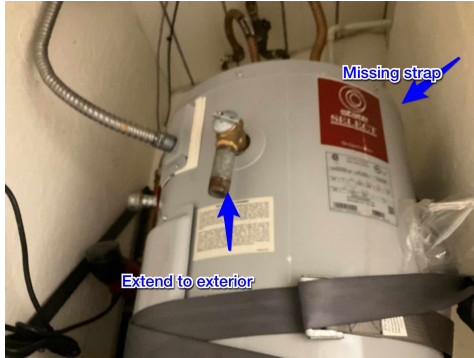
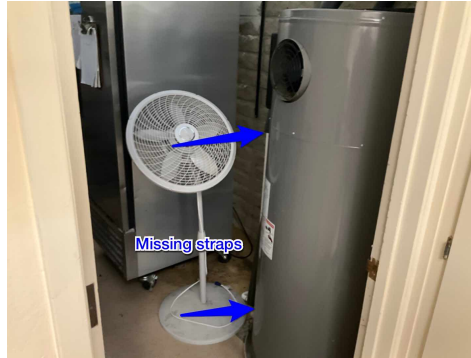
**13:** The water heaters are serviceable. However, two of them need to be strapped and one of them needs the TPR valve pipe extended to the exterior. Recommend further investigation and repairs be made by qualified plumbing contractor.

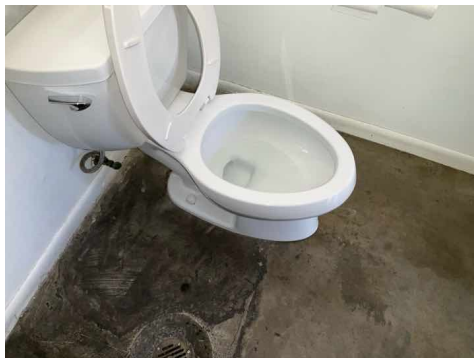
**s-14:** Use toilets should be properly fastened, and you should consider replacing the wax ring prior to resetting the toilet.

**14:** Use toilets should be properly fastened, and you should consider replacing the wax ring prior to resetting the toilet.

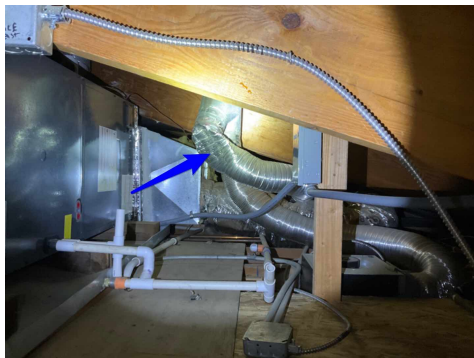
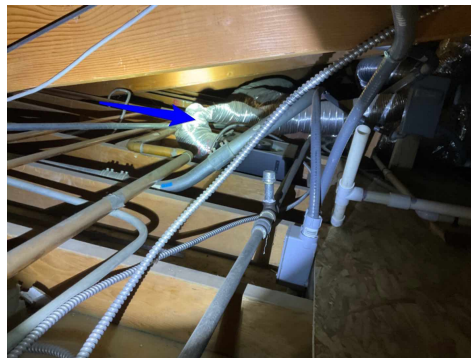
**s-15:** There are crushed exhaust vent ducks in the attic space of the main hall building. Recommend service.

**15:** There are crushed exhaust vent ducts in the attic space of the main hall building. Recommend service.

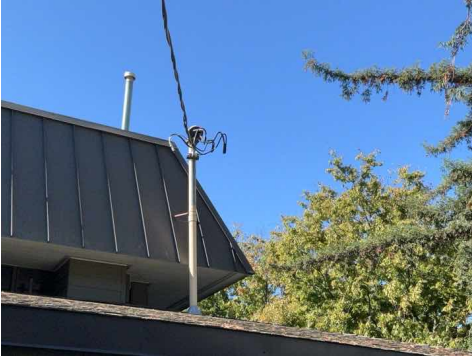
**s-16:** The wires at the main drop are not properly configured. Recommend service.

**16:** The wires at the main drop are not properly configured. Recommend service.

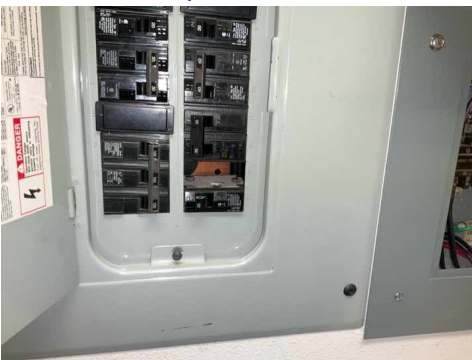
**s-18:** All interior panels should be checked for voids and the voids properly covered.

**17:** Zinsco electrical equipment is considered obsolete, due to a design flaw in which the circuit breaker's connection to the bus bar becomes loose, causing arcing and subsequent overheating. Long term exposure to this heat can cause the breaker to fuse to the bus bar, making it impossible to remove. Even worse it can cause the breaker's contacts to fuse together, thus preventing the breaker from tripping even in an over-current situation, thereby causing a potential fire hazard. however, it may be more cost effective simply to replace the entire panel with a more modern and safer design from another manufacturer. If the bus bar shows signs of corrosion, or if any of the breakers show signs of overheating, the panel should be replaced entirely. Many electricians advocate replacement of the panel in any case, due to its historically poor reliability. Recommend further evaluation of the electric panel and repairs/upgrades done as needed by a licensed electrician.

**18:** All interior panels should be checked for voids and the voids properly covered.

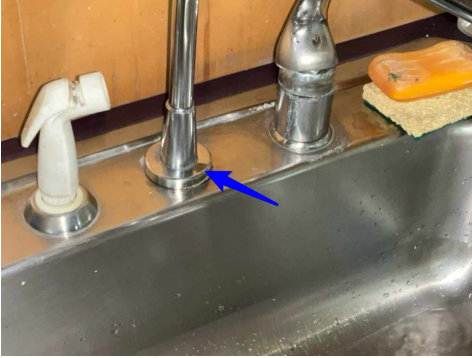
**s-19:** Faucets should be properly fastened down. Recommend service.

19: Faucets should be properly fastened down. Recommend service.

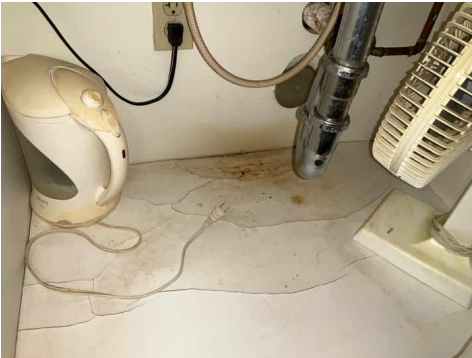
**s-20:** The floor on the sink cabinet is moisture damaged and there is the presence of mold. Recommend service.

20: The floor on the sink cabinet is moisture damaged and there is the presence of mold. Recommend service.

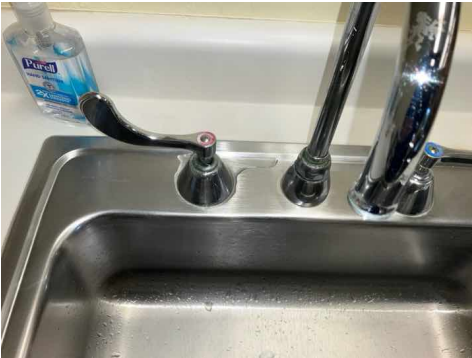
**s-21:** Seals should be checked for leaks. There is a leak on the hot water side in the nursery.

21: Seals should be checked for leaks. There is a leak on the hot water side in the nursery.

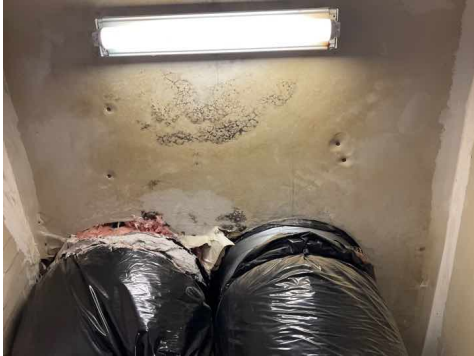
**s-22:** There's moisture damage and mold present on the ceiling of an exterior closet where there are two furnaces at the front of the main hall building. Recommend further investigation and all fungal growth be removed.

**22:** There's moisture damage and mold present on the ceiling of an exterior closet where there are two furnaces at the front of the main hall building. Recommend further investigation and all fungal growth be removed.
